DELAWARE RIVER BASIN
WEST BRANCH MIDDLE BROOK
SOMERSET COUNTY
NEW JERSEY

**WEST BRANCH
RESERVOIR
NJ 00372**

**PHASE 1 INSPECTION REPORT
NATIONAL DAM SAFETY PROGRAM**

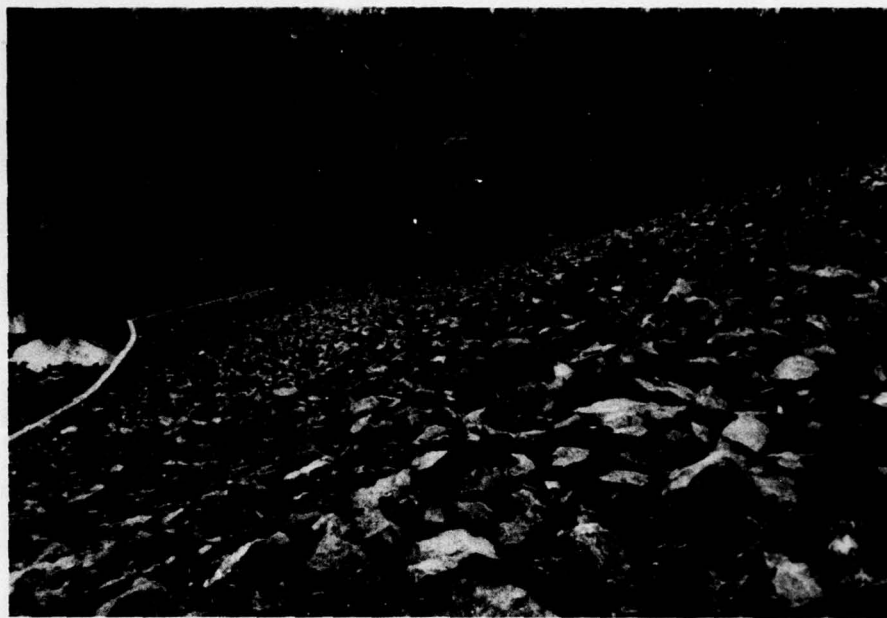
condition. It is completely covered with dumped rock riprap, and, possibly because of variations in thickness of the riprap, the slopes and crest are slightly uneven (Photo 1). The horizontal alignment of the crest is good. Riprap is missing from a small area near the spillway (Photo 2). There are no signs of erosion, and no seepage could be detected. The junctions of the embankment with the spillway and the right abutment appear to be tight, with no evidence of separation or movement.

Photo 1 - Rock facing on downstream embankment,
looking toward right (west) abutment.
(December 5, 1978)

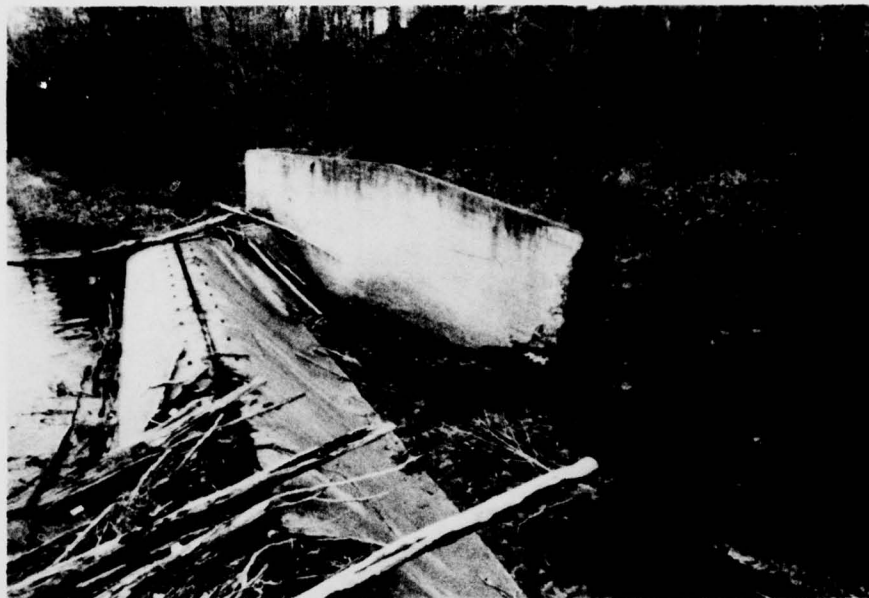
The spillway weir appears to be basically sound, but with indications of minor cracking, spalling and erosion (Photo 4). The weir has provisions for attaching flashboards but the boards have been removed (Photo 5). There has been minor erosion and slight undercutting of the channel at the base of the weir. The top of the right wingwall has broken off at the upstream end (Photo 6). The concrete at the downstream end of the left wingwall is spalled and there is evidence of leaching (Photo 7). There is some minor seepage through the abutment rock adjacent to this area.

Photo 5 - Spillway weir and left wingwall
(December 5, 1978)

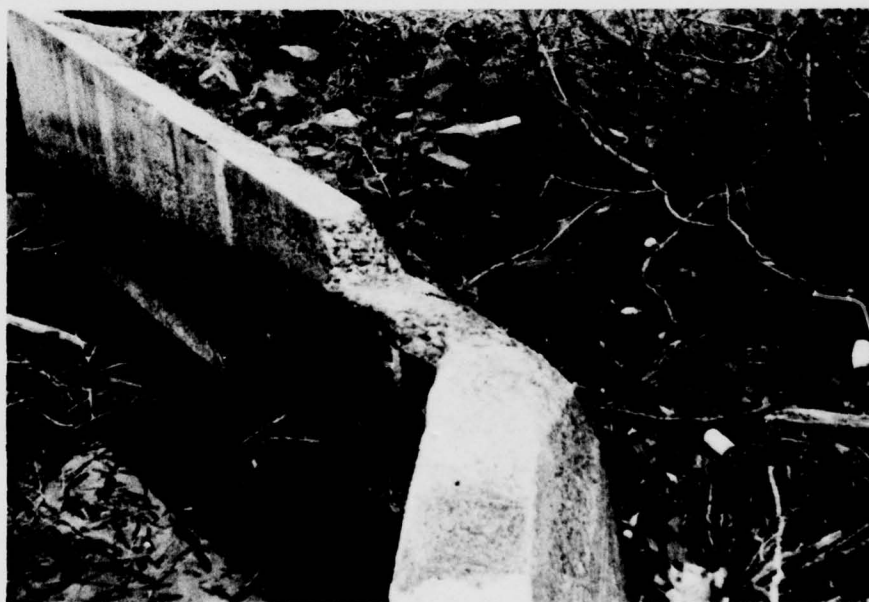
The concrete spillway appears to be in fairly good condition, although there is some erosion at the base of the weir and the right wingwall has been damaged. The natural rock spillway channel may be subject to some erosion and frost action along the joints, but basically the rock appears to be competent. The concrete training wall on the right side of the spillway channel is cracked in several places and the concrete is badly eroded from the base of the wall at several locations.

Photo 6 - Broken top of right wingwall of
spillway. (December 5, 1978)

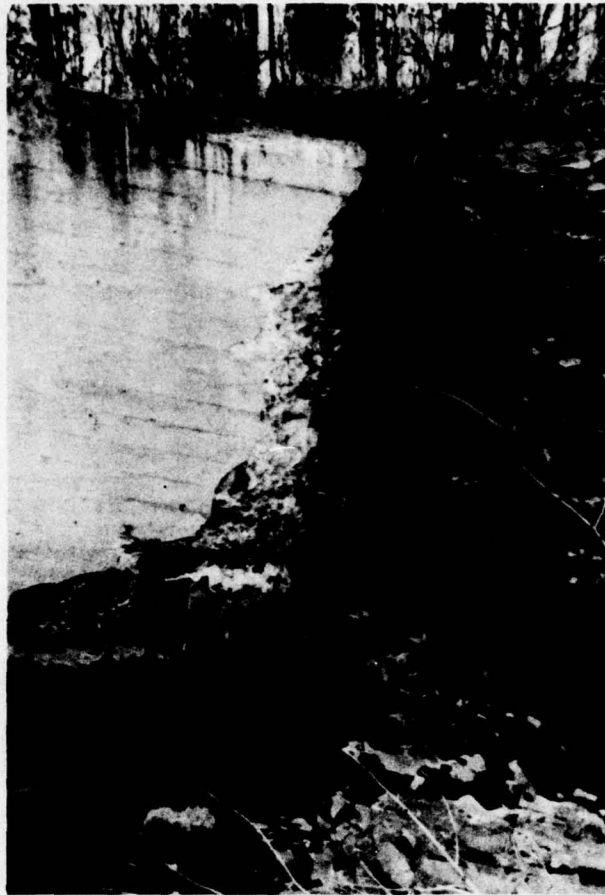
Photo 7 - Leaching
and spalling of concrete
at downstream end of
left wingwall. Minor
seepage through abut-
ment rock. (Dec. 5, 1978)

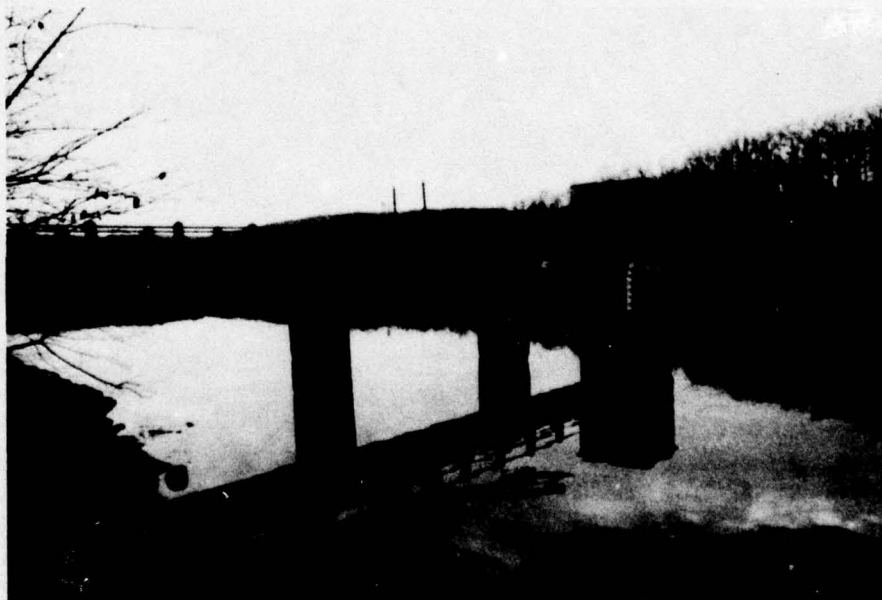
The only working reservoir outlet is the 24-inch diameter blowoff. It is operated from a control tower in the reservoir with access from a bridge on the right bank (Photo 10). Windows in the control tower or gatehouse are broken out and concrete has spalled from posts supporting the bridge railing.

Photo 10 - Gatehouse and staff gage near right bank of reservoir. (December 5, 1978)
